DAMAGE DETECTION IN CARBON FIBER REINFORCED POLYMERIC
COMPOSITES AND HONEYCOMB SANDWICH PANELS BY ACTIVE
THERMOGRAPHY

by
SEFA KEMAL MANDAL

Submitted to the Graduate School of Engineering and Natural Sciences
in partial fulfillment of
the requirements for the degree of
Master of Science

SABANCI UNIVERSITY
DECEMBER 2019

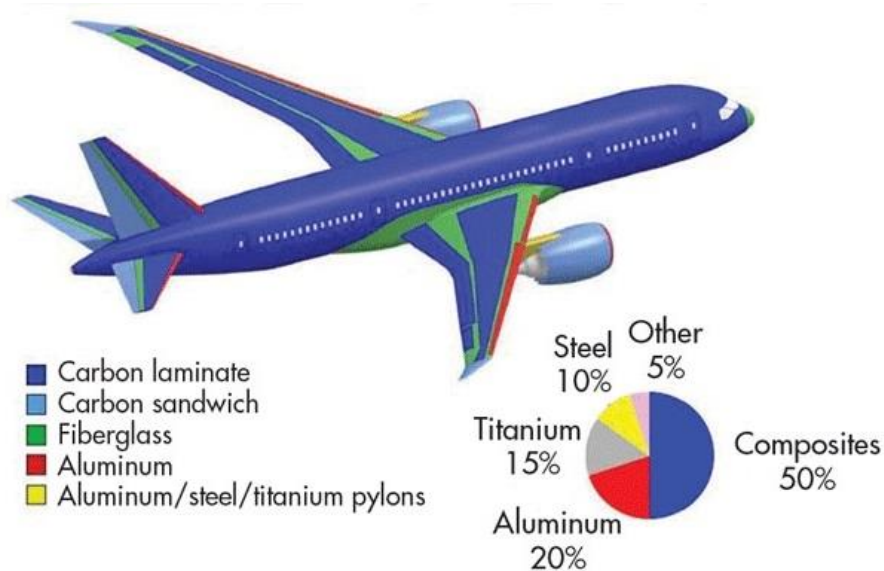
Figure 1.1 Distribution of used materials in Boeing 787 [4]

The use of carbon fiber reinforced polymers has increased considerably in recent years especially in the aerospace, automotive and marine industry due to their advanced specific properties such as high strength-to-weight ratio, corrosion resistance, improved fatigue behavior, high chemical and environmental resistance, high impact strength, etc. [1]–[3]. For example, as seen in Figure 1.1 about 50% of all materials used in a commercial Boeing 787 are made of composite materials which shows their importance in the aerospace industry [4].

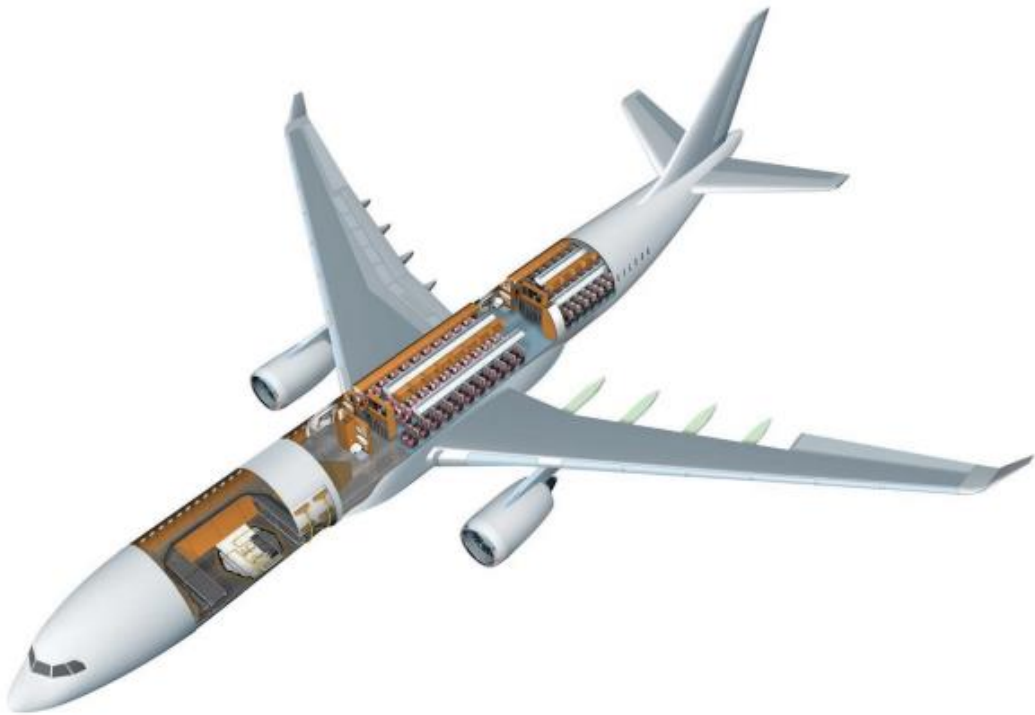
Figure 1.2 Representation of aircraft interior [7], [8]

using CF sandwich materials in the exterior of the aircraft. Sandwich structures used in the cabin interior are shown in Figure 1.2 and Figure 1.3.

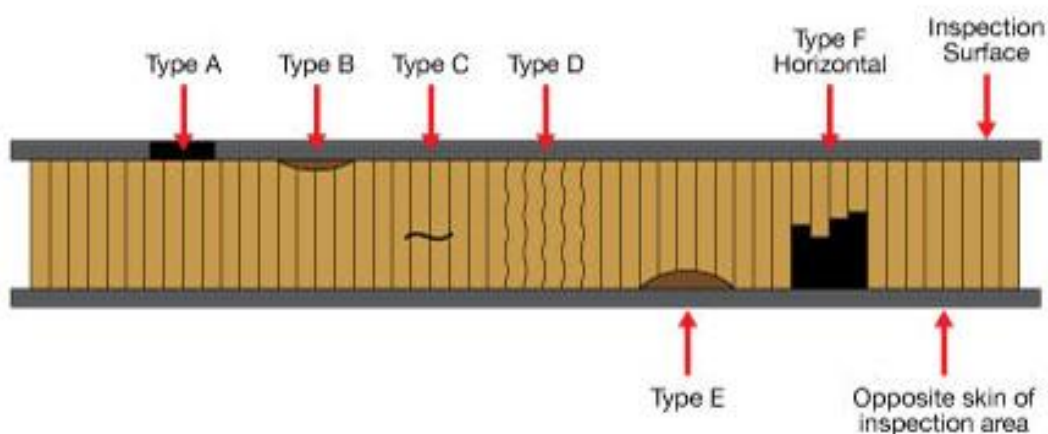
Figure 1.4 Defect types in sandwich composite plate [23]

Type A	Delamination
Type B	Debonding outer skin
Type C	Crack initiate
Type D	Crushed core
Type E	Debonding inner skin
Type F	Liquid ingress

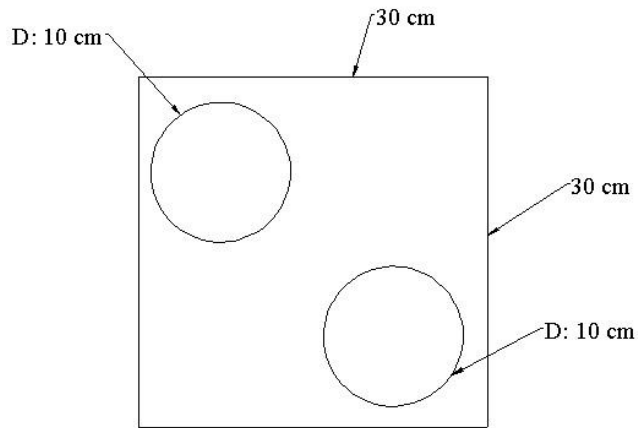
The first CFRPC sample was made of carbon fiber prepreg sample manufacturing with cross-ply laminates. The sample has 12 layers and has dimensions of 30 cm by 30 cm. Also, it has two-hole defects which given during manufacturing artificially with a radius of 5 cm, and the first hole defect of these is on the third layer of the specimen, the second one is on the sixth layer of the specimen. Hole defects and the two-dimensional drawing of the sample are given in Figure 2.1.

Figure 2.1 Drawing of two-hole defects sample

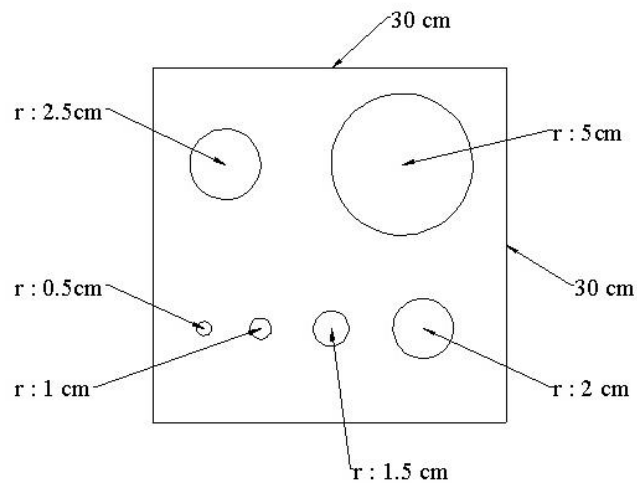
The second CFRPC sample was made of carbon fiber prepreg sample manufacturing with cross-ply laminates. The sample has 12 layers and has dimensions of 30 cm by 30 cm. Yet, in this instance, the size of the hole-defects has been altered and the number of defects has been increased. It has six-hole defects with a radius of 5 cm, 2.5 cm, 2 cm, 1.5 cm, 1 cm, and 0.5 cm, respectively. Hole defects and the two-dimensional drawing of the sample are given in Figure 2.2.

Figure 2.2 Drawing of six-hole defects sample

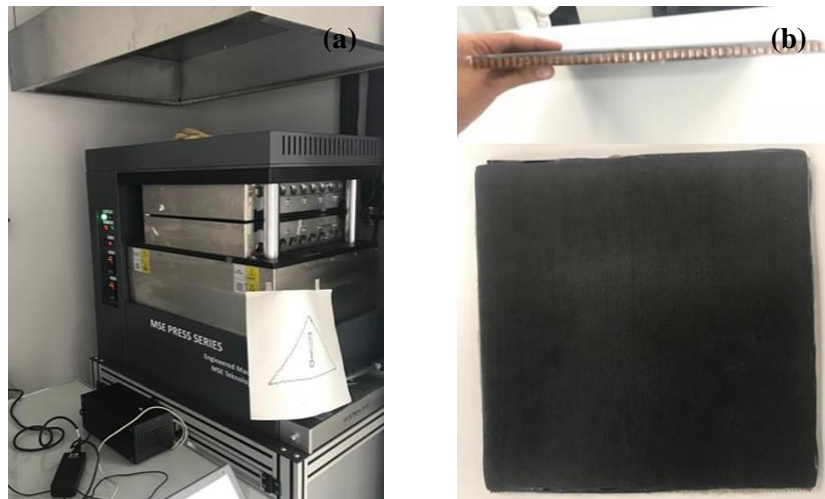
In order to inspect the sample with thermography, the specimen was prepared in a different orientation (0/90/0/90 | 90/0/90/0) and it was cured at 120°C for one hour with 5 tones hot press. Manufacturing processes and the sample can be seen in Figure 2.3-(a) and Figure 2.3-(b).

Figure 2.3 Representation of (a) hot press and (b) CF sandwich sample

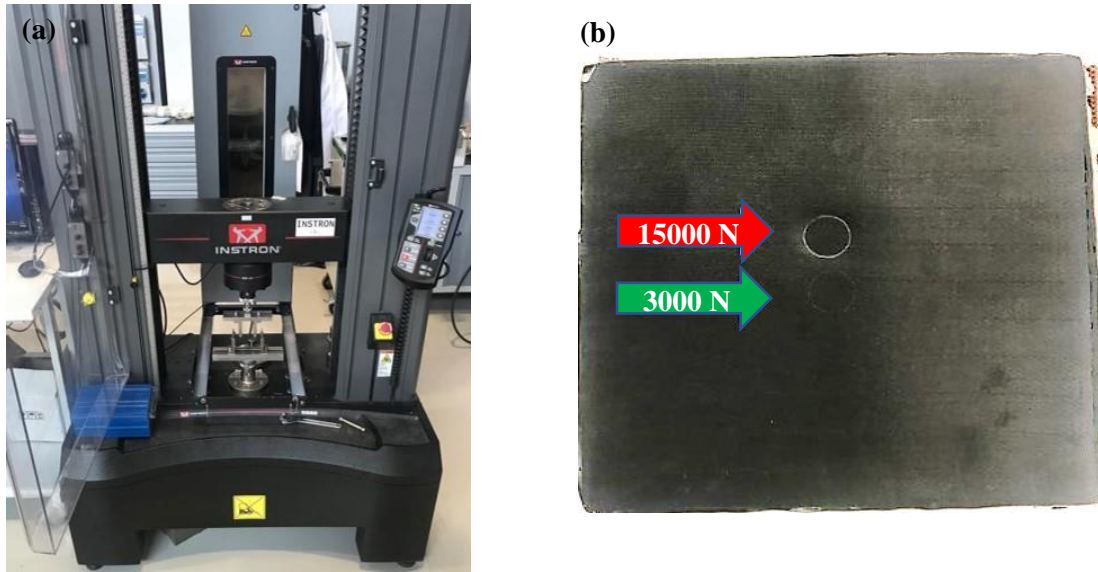
After the manufacturing of the CF honeycomb sandwich panel, the sample was subjected to compression tests in order to perform damage detection with the infrared thermography. The loads were applied to the sample surface as 3000 N and 15000 N with Instron 5982 electro-mechanical test machine with a capacity of 150 kN. Damaged surface and compression test equipment are given in Figure 2.4 and in Figure 2.4-(a), the upper arrow represents 15000 N and the below arrow represents 3000 N.

Figure 2.4 (a) Instron 5982 electro-mechanical test machine, (b) Damaged surface of CF sandwich structure

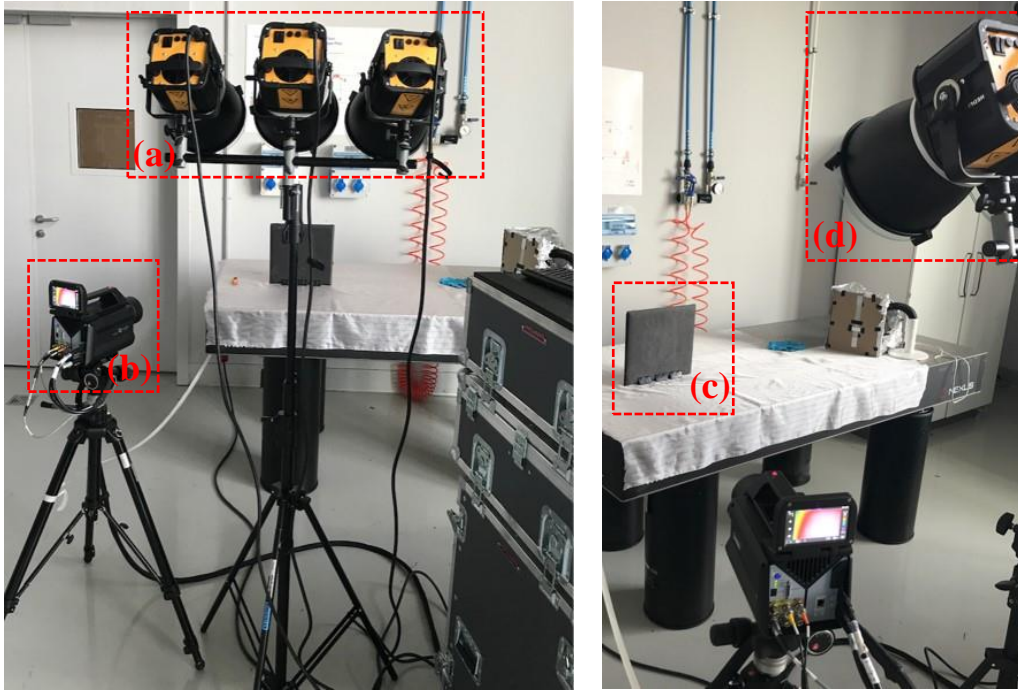
The LT and PT experiments were performed by using three Xenon halogen lamps (for LT) and flash lamps (for PT) as a heat source, a computer and FLIR X6580 SC with 25mm optical lens thermal imaging camera equipped with MWIR 640 x 512 sensor, thermal sensitivity is below 20 mK and has a capability of maximum frame rate at 355 Hz at 640 x 512 pixel. Afterwards, captured images were analyzed by using OTvis 6000 module of DisplayIMG 6 processing software (Edevis GmbH, Stuttgart, Germany) for LT test and by using PTvis 6000 module of DisplayIMG 6 processing software for PT test. Figure 2.5 presents the configuration of thermography tests for LT method (left image) and PT method (right image).

Figure 2.5 LT test setup (left image) (a) represents halogen lamps, (b) represents IRT Camera, PT test setup (right image) (c) represents CF sample and (d) represents flash lamp

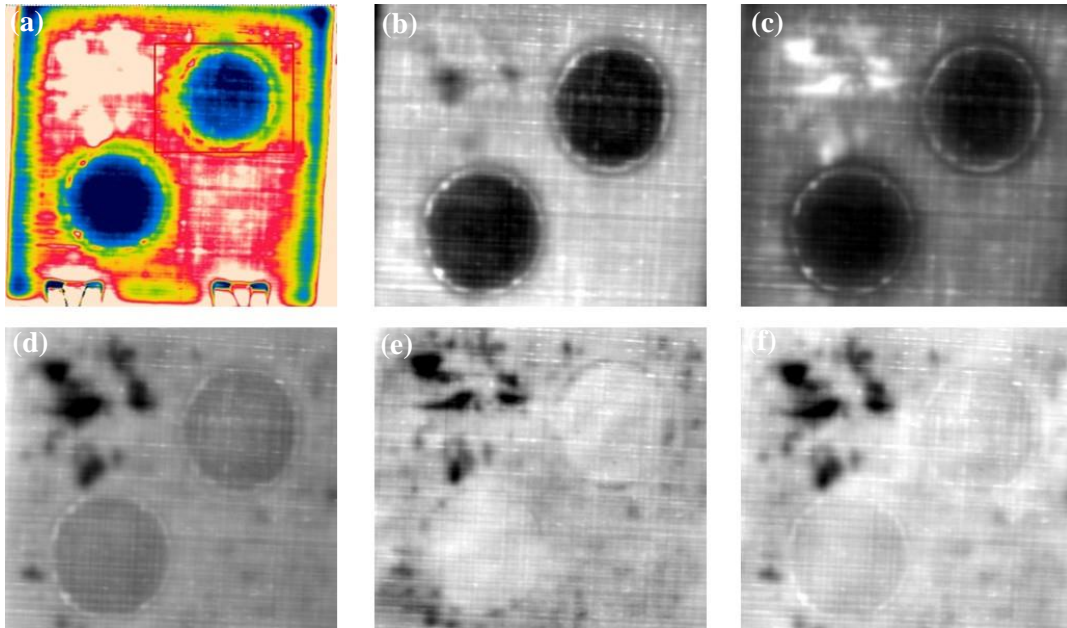
In order to have a clearer and sharper image of the hole-defects in Figure 2.1, different frequencies namely 0.01 Hz, 0.02 Hz, 0.03 Hz, 0.04 Hz, 0.07 Hz and 0.08 Hz were used. The results are phase variation at different parts of the sample for different frequencies are seen in Figure 2.6.

Figure 2.6 LT results of the two-hole defects (first sample) with different frequencies (a) 0.01 Hz, (b) 0.02 Hz, (c) 0.03 Hz, (d) 0.04 Hz, (e) 0.08 Hz, (f) 0.07 Hz

As seen in Figure 2.6, the two hole-defects in the sample are clearly visible when 0.01 Hz and 0.02 Hz are applied. As the value of frequency increases for thermal analysis, the exact size and boundaries of the defects become vague due to a decrease in penetration of thermal waves, this is because thermal diffusion length is directly proportional to the applied frequency which was indicated in Equation 1. However, the overall location of hole defects is identifiable since they are close to the surface of the sample. In conclusion, it can be said that using appropriate frequency for the detection of subsurface defects is crucial in CFRPC.

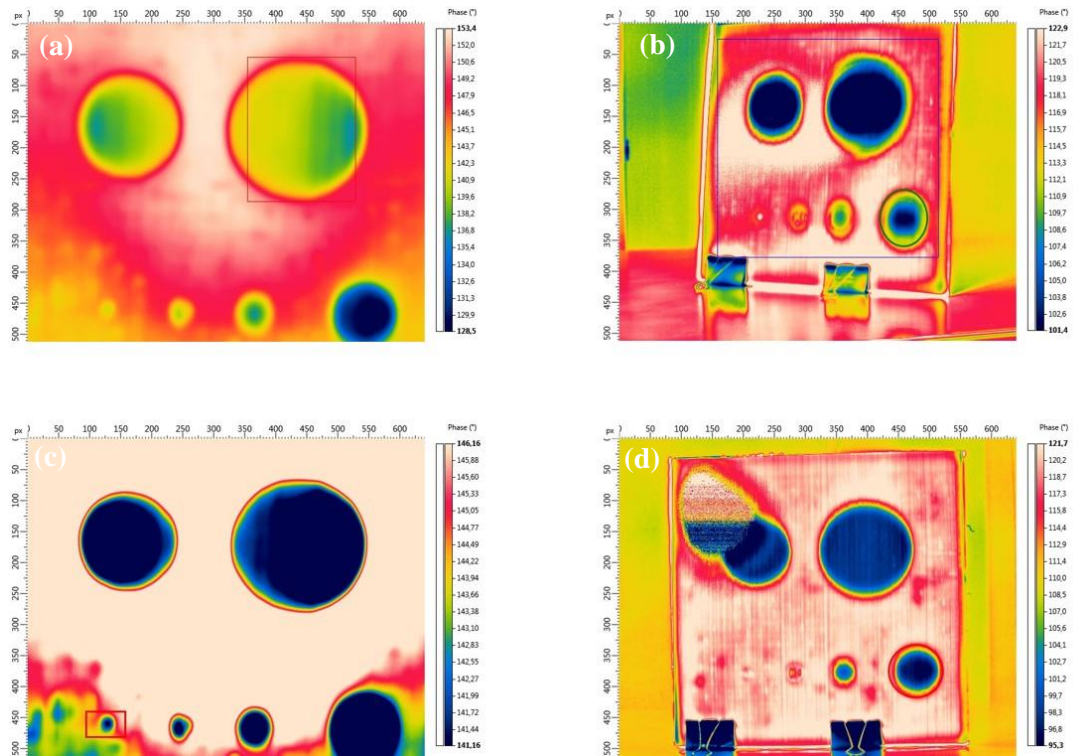
In order to detect hole-defects in different sizes as depicted in Figure 2.2, different frequencies namely 0.01 Hz, 0.02 Hz and 0.05 Hz were used. The corresponding LT results are shown in Figure 2.7. In order to obtain the best result for a 1 cm defect within the sample, an extra analysis was conducted at 0.01 Hz in a small region of interest (ROI). It must be mentioned that the optimum range of frequencies used for this sample selected based on the results of LT for the first sample as discussed in Section 2.3.1.

Figure 2.7 LT results of six-hole defects (second sample) with different frequencies (a) 0.01 Hz, (b) 0.02 Hz, (c) 0.01 Hz with different region of interest, (d) 0.05 Hz

Figure 2.7 shows the test result of the six-hole defected sample (second sample). It is seen that the holes with the size of 3 to 6 cm in diameter are clearly visible using any frequency and their boundaries are vivid. However, the location and size of the defects with 1 and 2 cm in diameter are not visible sufficiently when 0.05 Hz and 0.02 Hz frequencies are applied. This uncertainty for small defects can be attributed to the hardware limitation of the thermal camera or the region of interest which is being used for thermal analysis. To overcome this problem using a small region of interest can be helpful, therefore a smaller region of interest is selected at the approximate location of the smallest hole defect as seen in Figure 2.7-(c). This approach helps to identify the exact location and size of the small defect inside the sample. The phase difference between the center of the smallest defect and its surroundings is about 5°, while the phase difference of the entire sample surface as seen in Figure 2.7-(b) is approximately 21°.

Equation 3 (Section 1.2.3.1). Therefore, with deeper subsurface defects can be detectable using lower frequencies. In other words, the results of LT for sample 2 show that the exact position of the hole-defects can be found with low frequencies since heat propagates homogeneously at low frequency as compared to high frequency.

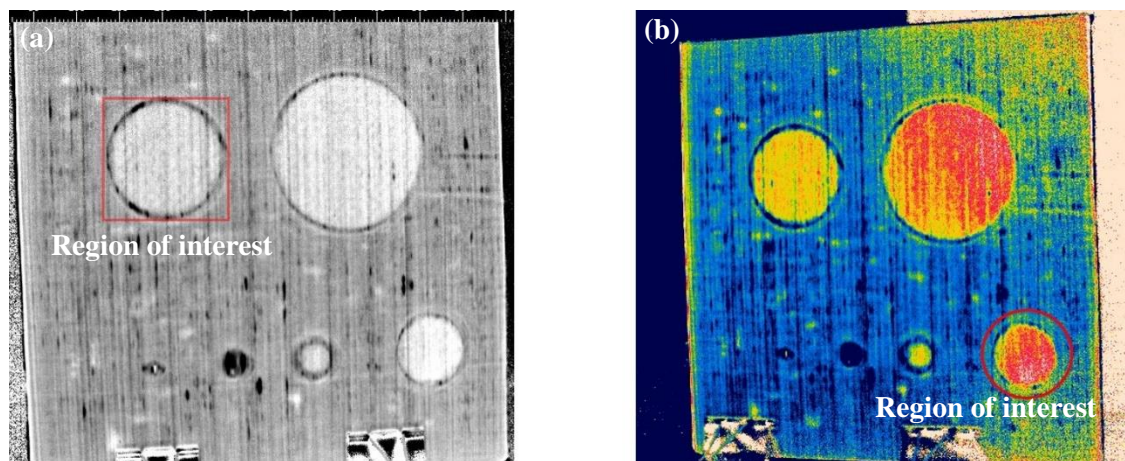
Apart from the LT tests, PT measurements were also used for the second sample to detect six-hole defects with different sizes inside the material. As can be seen in Figure 2.8, hole defects could be detected by using PT method except for a 1 cm defect. The reason for data loss in small defects, i.e. 1 cm-hole and 2 cm-hole in diameter, can be related to inherent variation in the wavelength of the excitation source, reflection caused by environmental noise and inhomogeneous heating of the material surface.

Figure 2.8 PT results of six-hole defects (second sample) (a) 1 Hz flash frequency, (b) 1 Hz flash frequency with different region of interest

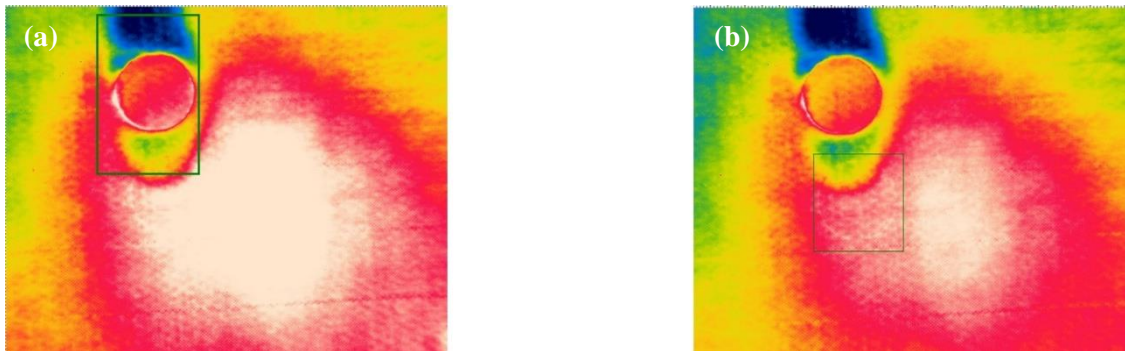
LT and PT methods were used to detect and analyze the effect of compressive loading levels namely 15000 N and 3000 N, on CF-based sandwich plate. Since the appearance of the defects are different, appropriate frequencies, sufficient to detect them, were used for LT and PT. As seen in Figure 2.9 and Figure 2.10, damage area as a result of 15000 N is clearly visible through thermal analysis. However, the defect caused by 3000 N is not vivid neither in PT nor LT measurements despite the selection of a smaller region of interest in Figure 2.9-(b) and Figure 2.10-(b). This observation suggests that thermal analysis cannot be used as a sole damage detection method, therefore utilizing a

Figure 2.9 LT results of CF sandwich plate after compression test (a) at 0.1 Hz LT frequency focusing 15000 N defect, (b) at 0.1 Hz LT frequency focusing 3000 N defect

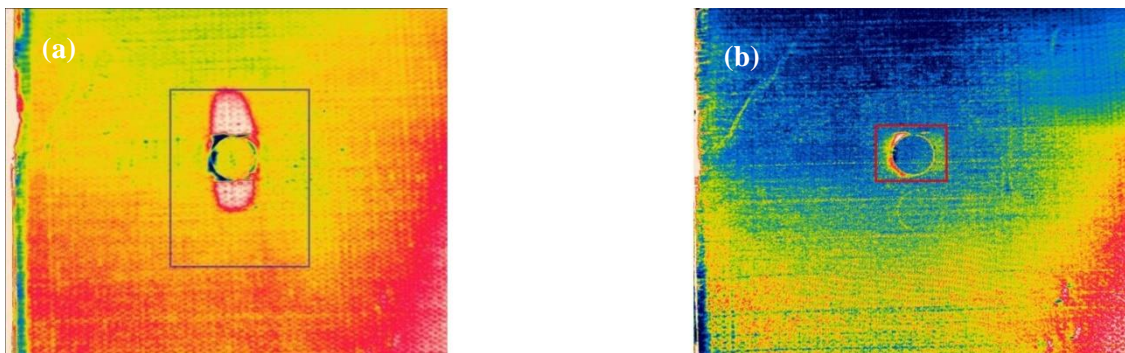
Figure 2.10 PT results of CF sandwich plate after compression test (a) 1 Hz frequency focusing 15000N defect, (b) 5 Hz frequency with different ROI

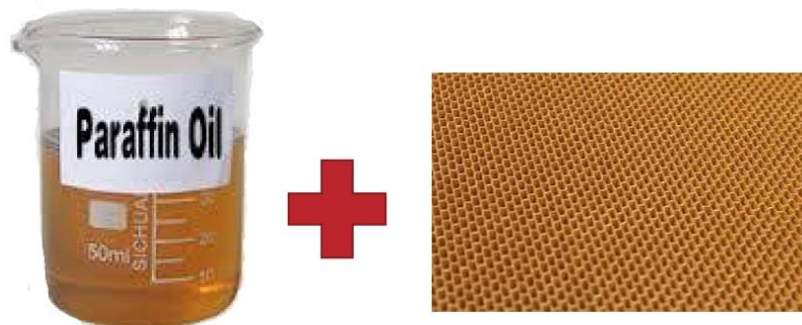
The sandwich panels are sensitive for moisture caused by environmental factors and consequently they are susceptible to liquid ingress. This leads to the degradation of the thermo-mechanical properties of the sandwich panels. To simulate this condition, paraffin oil produced by Sigma-Aldrich was embedded in the honeycomb cells before the curing in order to detect the liquid ingress. After curing the material, LT and PT tests were applied separately for the detection of the liquid in the material. A representative image of the defect formation is given in Figure 3.2 below:

Figure 3.2 Representative illustration of embedding paraffin oil in cells before curing

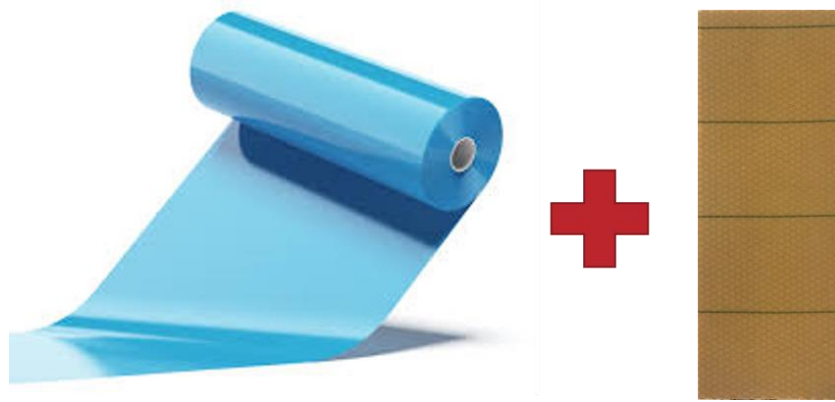
Debonding in sandwich panels might result in core crush and consequently a catastrophic failure. This failure might happen due to defects created during the lay-up of raw materials e.g. wrinkling of the face sheet. They initiate when compressive forces are subjected to the material. Herein, we used a Teflon film between the face sheet and the core during manufacturing to create a debonding on purpose and detect it by LT and PT methods. Representative image of placing Teflon film between face sheet and core is shown in Figure 3.3.

Figure 3.3 A representative illustration of embedding Teflon film into sample to create debonding

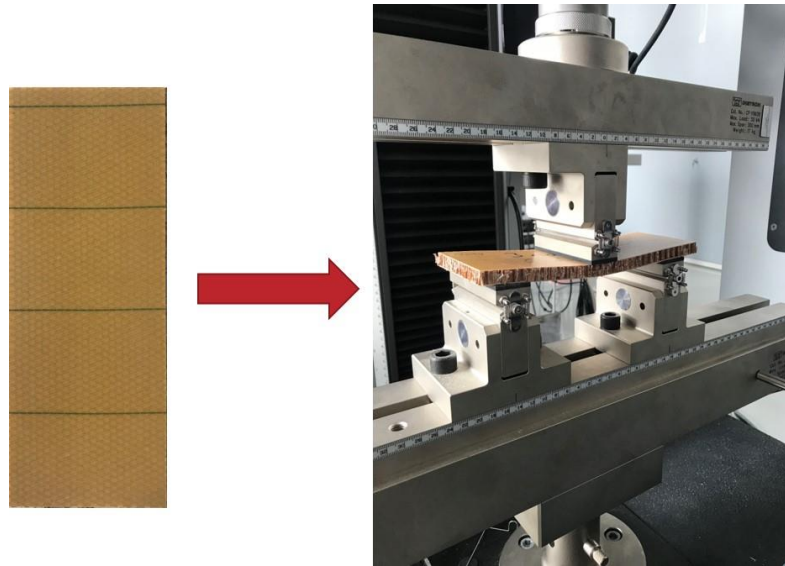
One of the most common defects in sandwich panels encountered during the manufacturing, as well as during in-service, is delamination. Since this defect emerged inside the material, it is very difficult to determine with the naked eye. In order to assess the detectability of LT and PT for the delamination, 3-point bending tests with different end load levels were applied onto samples. Sandwich panels were subjected to 3-point bending test based on ASTM C393 [45] standard with Instron 5982 electro-mechanical test machine which described in Chapter 2 (compression test part) and Figure 2.4. The distance between the support spans was 150 mm. A displacement-controlled test was carried out with a displacement rate of 6 mm/min. The representation image of the delamination formation caused by the 3-point bending test is given in Figure 3.4 as below.

Figure 3.4 Representation of delamination formation

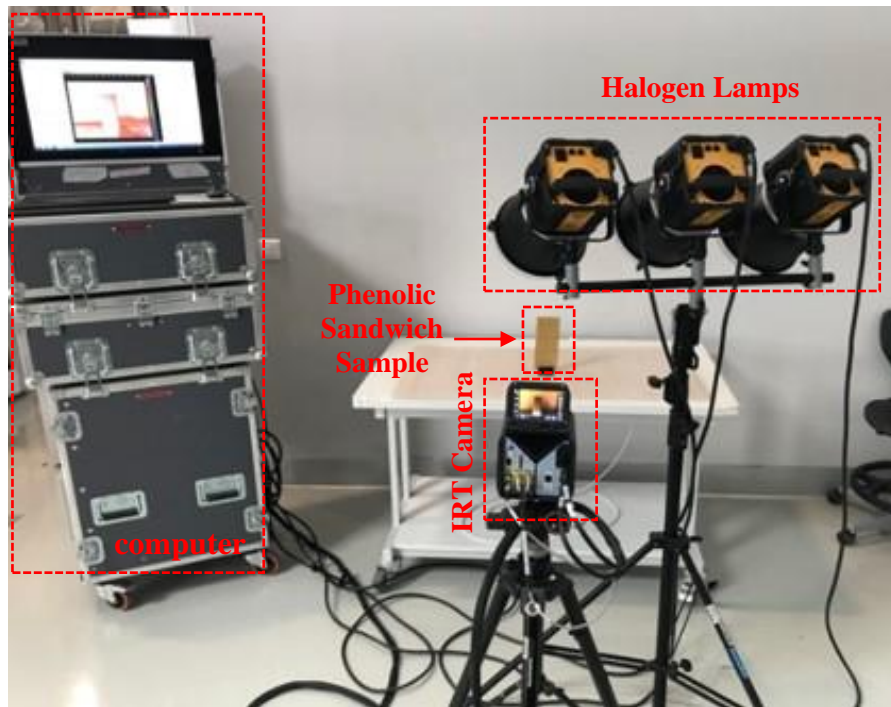
The setup of LT and PT tests is the same as in Chapter 2, and the setup is shown in Figure 3.5 and Figure 3.6. Besides, taking Equation 1 and Equation 3 (Section 1.2.3.1) into consideration for LT method, the depth of the defect in the sample varies according to the frequency of the heat source, i.e. the lower the frequency is given, the deeper the defect is detected. Accordingly, different frequencies were used from 0.1 Hz to 0.002 Hz in order to locate the depth of defects in LT experiments. In particular, very low frequencies were given to the delaminated sample since the damage takes part in very deep (approximately 4 mm). The depth of the defects that can be detected approximately according to the given frequencies is shown in Table 3-1. Furthermore, according to Equation 1 and Equation 3, a correlation between defect depths and frequencies was calculated and it is depicted in Figure 3.7 which will be used as a calibration graph to estimate the defect depth.

Figure 3.5 LT test set-up for the examination of phenolic sandwich structures

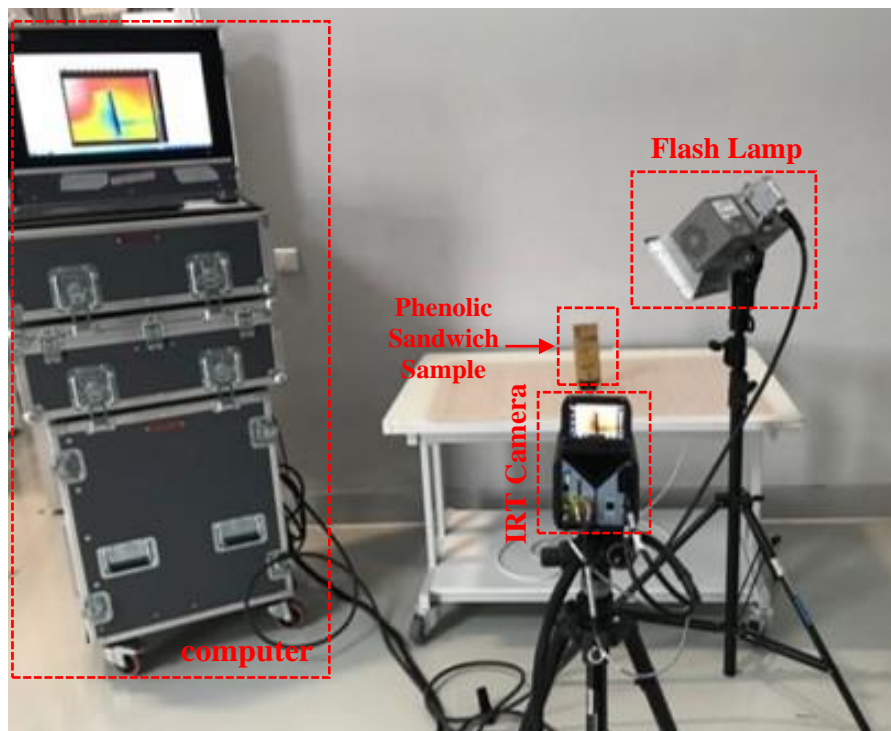
Figure 3.6 PT test set-up for the examination of phenolic sandwich structures

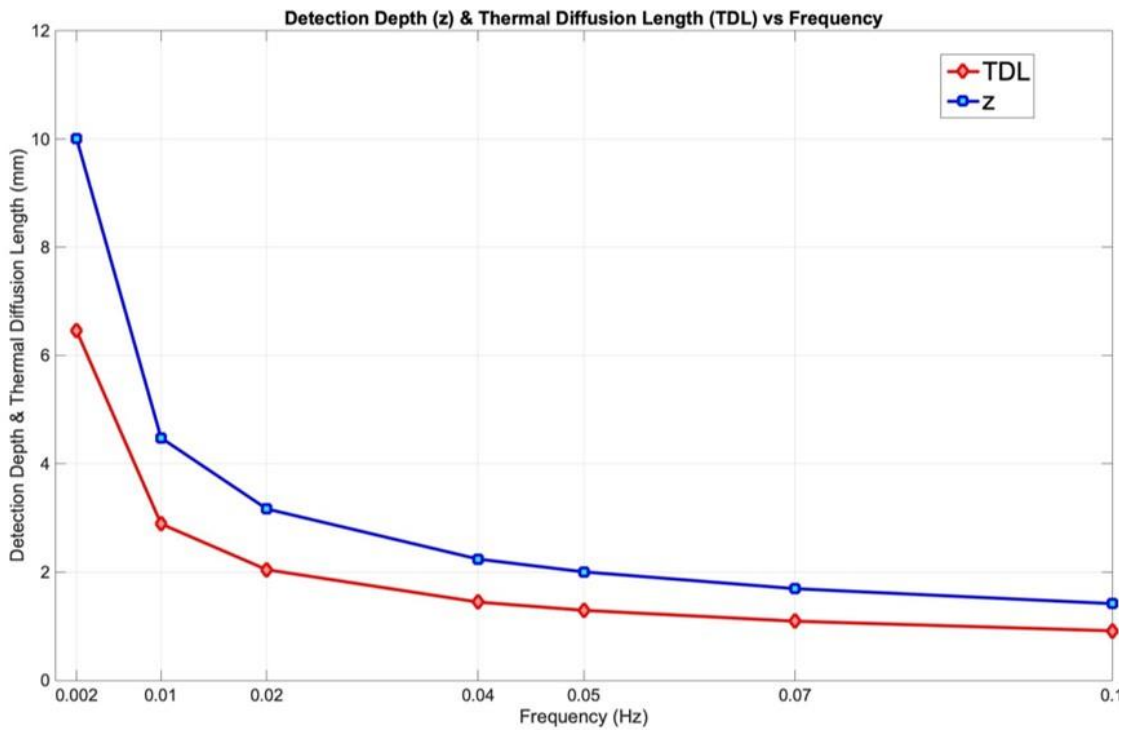
Figure 3.7 Detection depth & thermal diffusion length (mm) vs. modulated frequency

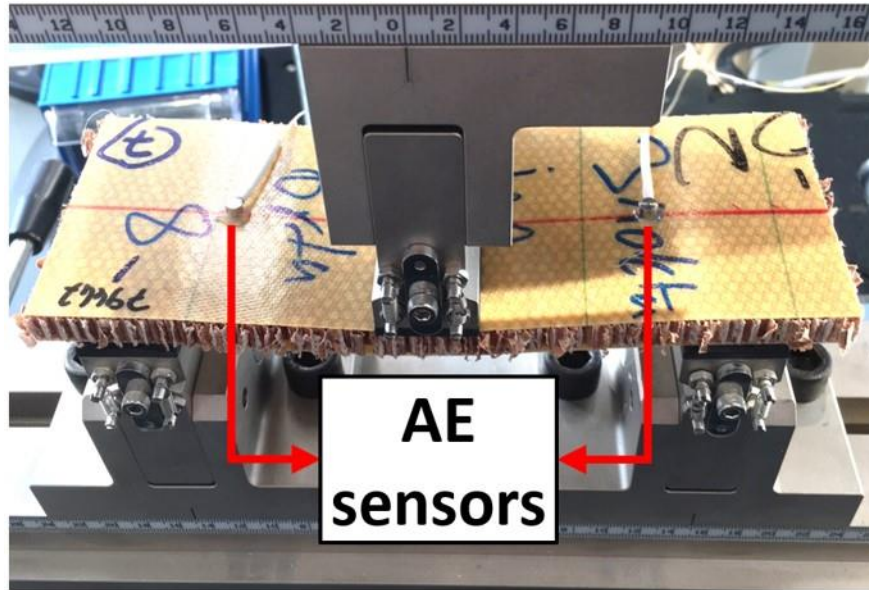
AE events during 3-point bending tests were carried out with Mistras PCI 2 acoustic emission apparatus with AEwin PCI2-4 software. Two sensors were placed on the specimen surface during bending tests. The specimen with AE sensors during the bending test is illustrated in Figure 3.8. The sampling rate is 2 MHz for each sensor. Registered AE signals were transformed into digital signals by using Noesis 7 Software to get the frequency domain.

Figure 3.8 Placing AE sensors during 3-point test

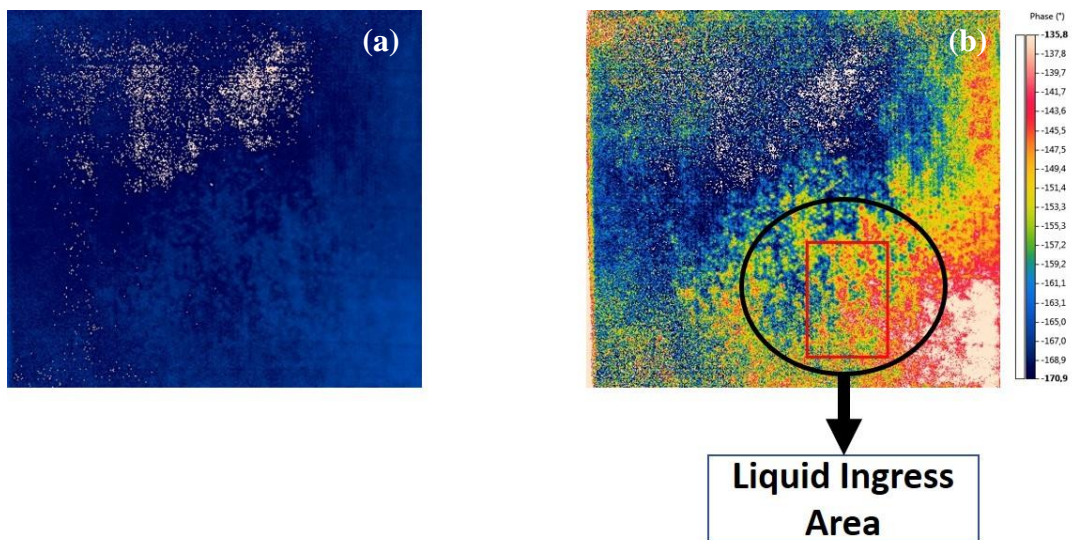
The pre-embedded paraffin oil inside the honeycomb core cells could be detected in both LT and PT methods. Selected results are depicted in Figure 3.9, Figure 3.10 and Figure 3.11, and the rounded regions indicate the liquid ingress location in the material.

Figure 3.11 PT images: (a) raw image and (b) at frequency of 1 Hz for liquid ingress test in sandwich composite

In the liquid ingress sample as presented in Figure 3.9, Figure 3.10 and Figure 3.11, both LT and PT methods could detect the pre-embedded Paraffin oil inside the honeycomb core cells. In the circled region in Figure 3.10 and Figure 3.11, blue spots and their

surrounding are present the liquid in the sample. The LT approach provides a clearer and sharper visualization of the defect, this clarity is related to the energy deposited onto the surface of the test specimen with a heat source having a single frequency in LT. In other words, the area of liquid ingress in the sample is clearly detectable due to equal and sufficient energy with the usage of a single frequency, i.e. all heat sources convey the same signal simultaneously over the same frequency channel. Moreover, the liquid ingress region in the sample could be obtained with different frequencies (e.g. 0.01 Hz and 0.05 Hz), see Figure 3.10. However, Figure 3.10-(a) gives the more explicit and clearer result as compared with Figure 3.10-(b) since the heat is distributed more homogeneously on the sample, i.e. the lower the frequency the deeper the heat penetration. This result also corresponds to the estimated depth of defect at given frequency as given in Table 3-1. According to Table 3-1, if a frequency of 0.01 Hz is applied, a defect of 4.4787 mm depth is detected, and/or if a frequency of 0.05 Hz is applied, a defect of 2,0029 mm depth is detected. Therefore, it is seen that the liquid ingress is about 4.5 mm deep in the sample as can be seen in Figure 3.10-(a). On the other hand, although liquid in the sample was detected by PT after applying FT to the raw image, the results are not as explicit as LT. The reason for this, the energy deposited on the surface of the test material by using flash as a heat source causes reflections and non-homogenous heating in the material at different frequencies.

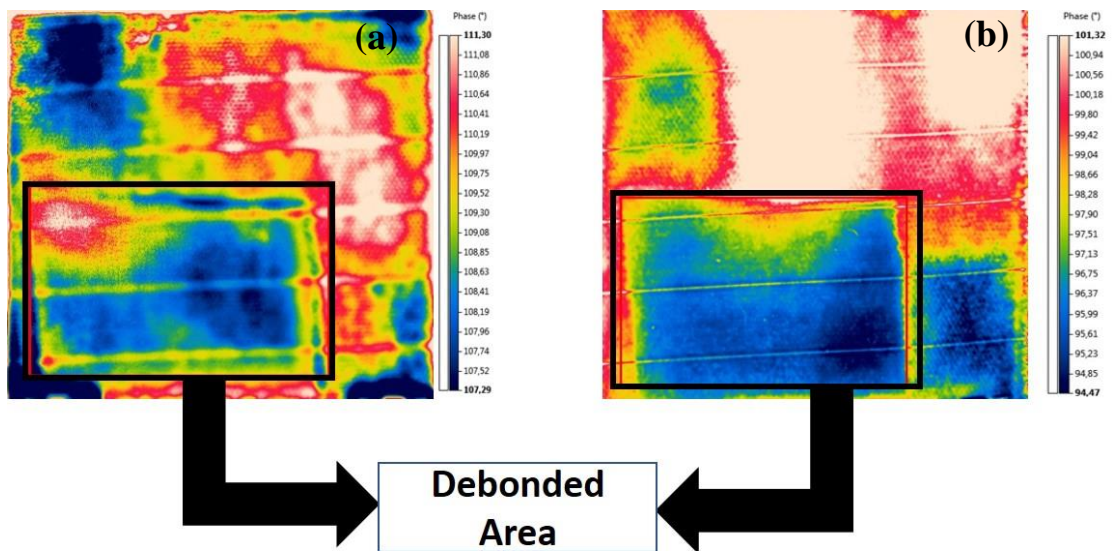
Debonding can be clearly observed by both LT and PT methods. The results are as indicated in Figure 3.12 to Figure 3.15. They present the detection of Teflon film in the enframed region.

Figure 3.13 LT images: (a) at frequency of 0.01 Hz and (b) at frequency of 0.07 Hz for debonding in sandwich composite

For the second specimen with Teflon film between the face sheet and the core, i.e. artificial debonding, can clearly be detected by both PT and LT methods as shown in Figure 3.13 and Figure 3.15. In this defect type, LT method provided better insight into the internal damage compared to PT even in higher frequency, because the damage emerged in the subsurface of the sample. Since there is a possibility of controlling the thermal exposure of the specimen surface in terms of intensity in LT technique, a better result for the subsurface defect is obtained. On the other hand, PT suffers from non-uniform exposure and non-uniform heating due to emissivity variations. Despite these

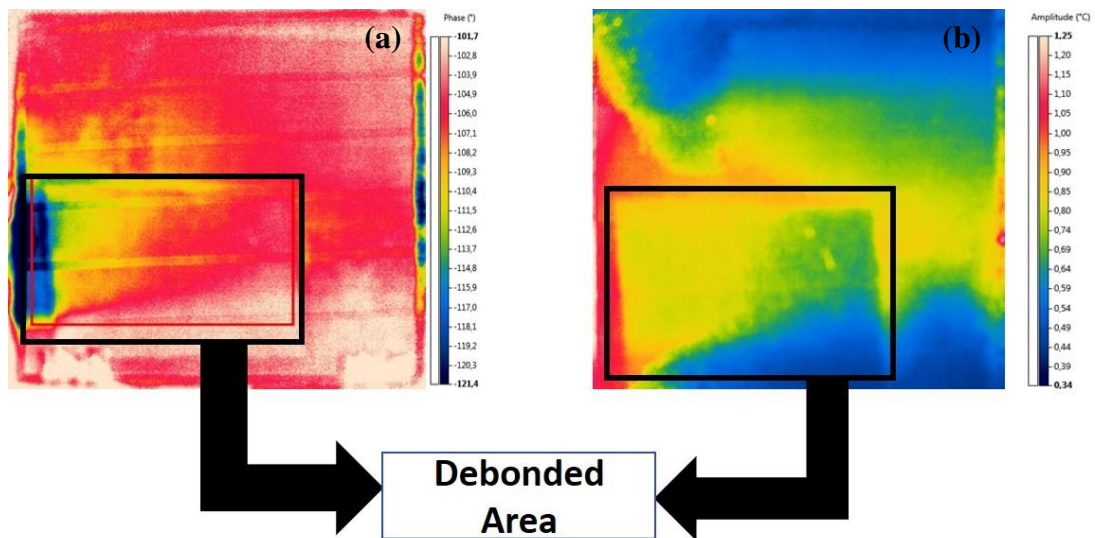
Figure 3.15 PT images: (a) at frequency of 1 Hz (phase mode) and (b) at frequency of 1 Hz (amplitude mode) for debonding in sandwich composite.

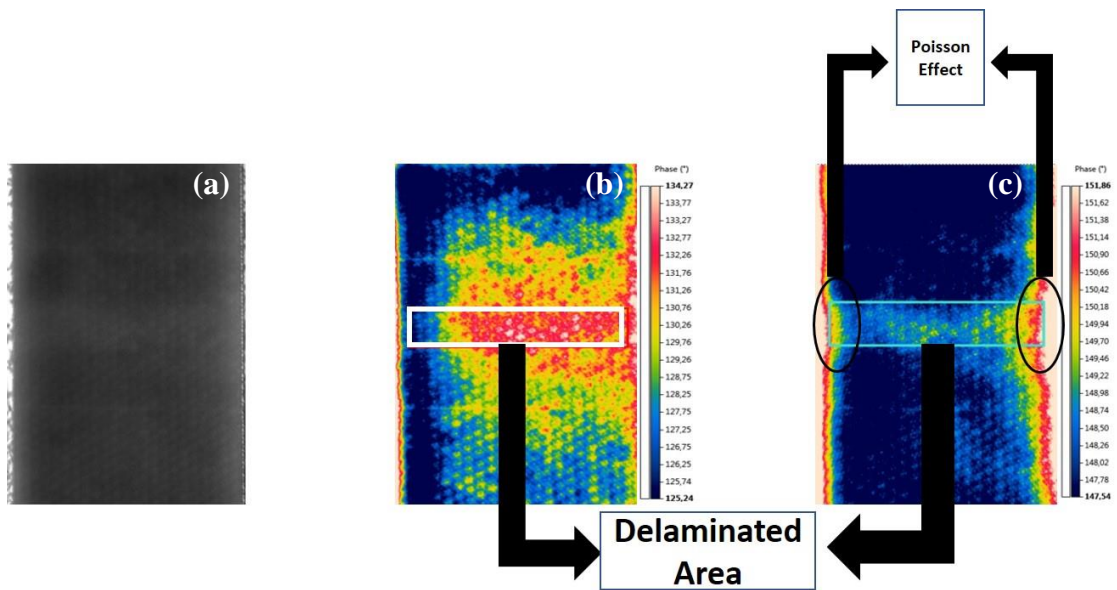
Samples were examined by LT and PT on defective and non-defective surfaces after out-of-plane bending. However, damage boundaries were determined only by the LT method when examined from the non-defective side. Selective results analyzed from the non-defective side are exhibited in Figure 3.16 and Figure 3.17.

Figure 3.16 LT images: (a) raw image, (b) at frequency of 0.01 Hz, c) at frequency of 0.002 Hz for 3-point bending test in sandwich composite captured from non-defective side

Comparing the results recorded by IR camera in Figure 3.16 and Figure 3.17, one can easily say that LT is able to detect delamination in phase image from non-defective region. Since the phase image in LT is relatively independent from the optical and thermal surface properties, the detected defect is most clearly visible in phase mode. Here, LT method provides a more accurate view on damage boundaries, and with higher precision to detect the damage depth compared to PT. Moreover, LT reveals the different defects formed after bending in the vicinity of the sample. To get a comprehensive understanding of the damage at a different depth of specimen various frequencies were applied based on the estimation made by Equation 1 and Equation 3 in Chapter 1, and the corresponding estimated depths of defects according to the applied frequencies are shown in Table 3-1 and Figure 3.7. In particular, the delamination resulting from the out-of-plane bending test in the sample of Figure 3.16-(c) is approximately 10 mm deep and this depth is determined if 0.002 Hz modulated-frequency is applied in LT. This observation verifies the estimated damage depths according to the applied modulation frequency shown in Table 3-1 and Figure 3.7. Furthermore, it can be clearly seen that the Poisson effect after the test caused by bending load can be detected in Figure 3.16-(c) if very low frequency is applied. Hence, it can be said that the effect of modulation frequency on the depth of detected damages was validated by other experimental methods. It can be concluded that lower frequency reveals information of damage at higher depth while higher frequencies provide information closer to the surface of the specimen.

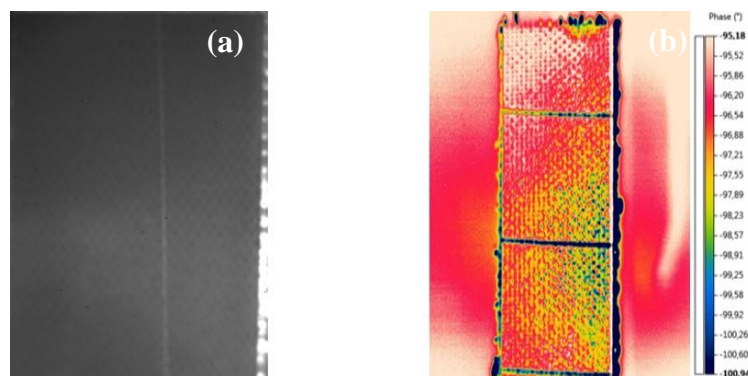
Figure 3.17 PT images: (a) raw image, (b) at frequency of 1 Hz for 3-point bending test in sandwich composite captured from non-defective side

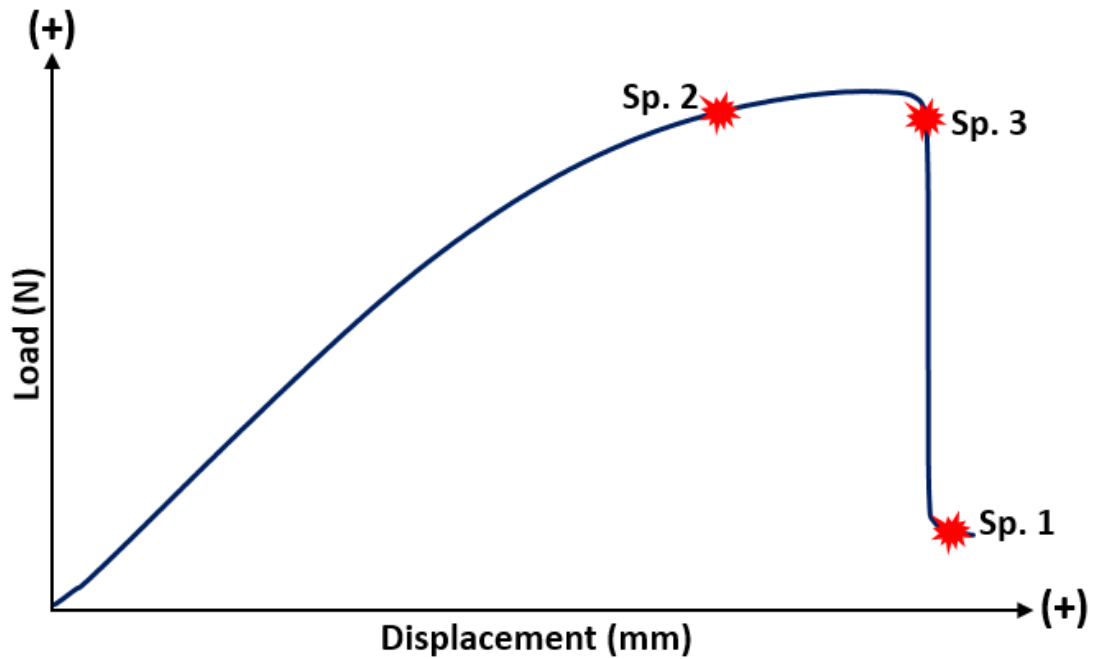
In order to make a correlation between the AE results and thermography inspections of induced damage modes, tests were interrupted at 4 different levels. Only one test was performed until the final fracture. All tested specimens were compared with a reference sample that was not tested. Four interruption levels are marked as shown in Figure 3.18.

Figure 3.18 Test interruption levels of specimens with respect to Load vs. Displacement diagram

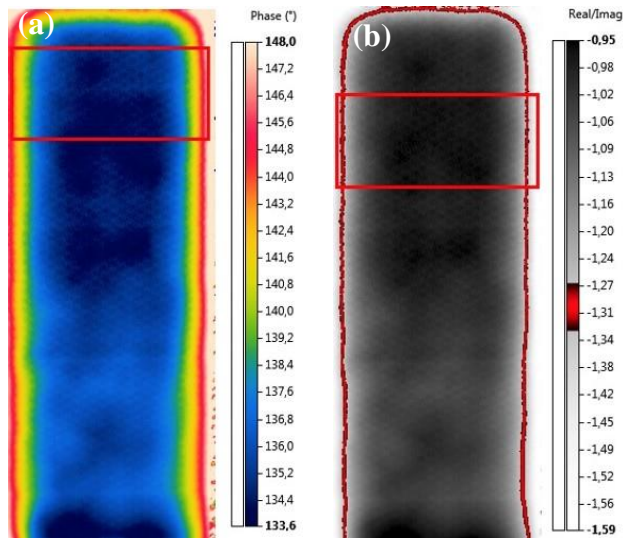
Figure 3.19 The LT results of reference sample (untested): (a) FT at front image frequency of 0.002 Hz (phase rain mode), (b) front image frequency of 0.002 Hz (real/imag iron mode)

0.002 Hz, which is very low, LT frequency was applied to the sample shown in Figure 3.19 in order to compare with tested samples. As can be seen in both Figure 3.19-(a) and Figure 3.19-(b) there is no defect and damage boundary in the sample.

AE registrations applied onto samples during 3-point bending, and they were examined by LT on defective and non-defective surfaces after 3-point bending. The reference sample which was not undergone the test is shown in Figure 3.19. Selective results analyzed by LT after the tests and the data obtained from the AE sensors during the tests are shown in Figure 3.20 to Figure 3.22.

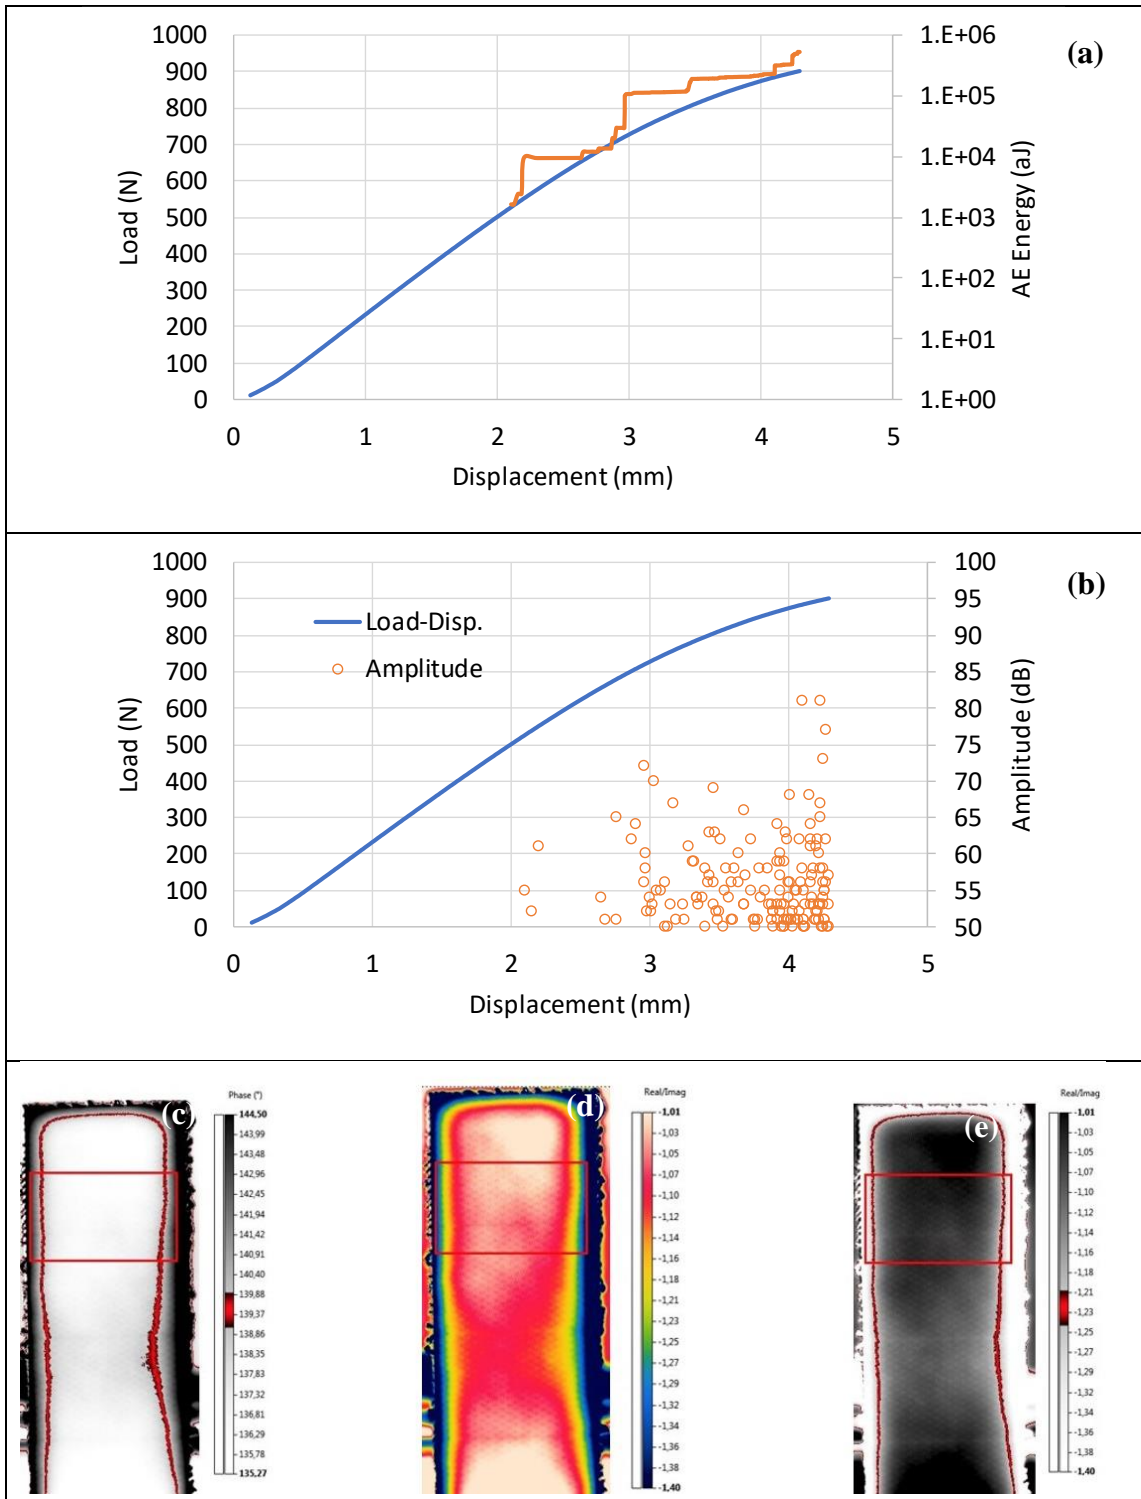
Figure 3.21 AE and LT results of Sample 2 (a) cumulative AE energy, (b) average amplitude values of AE, (c) front image frequency of 0.002 Hz (phase iron mode), (d) rear image frequency of 0.002 Hz (real/imag rain mode), (e) rear image frequency of 0.002 Hz (real/image)
